# San Francisco Sewer Inspection Methodology Presentation

October 13, 2016

# Latest Equipment Acquisition: Electro Scan

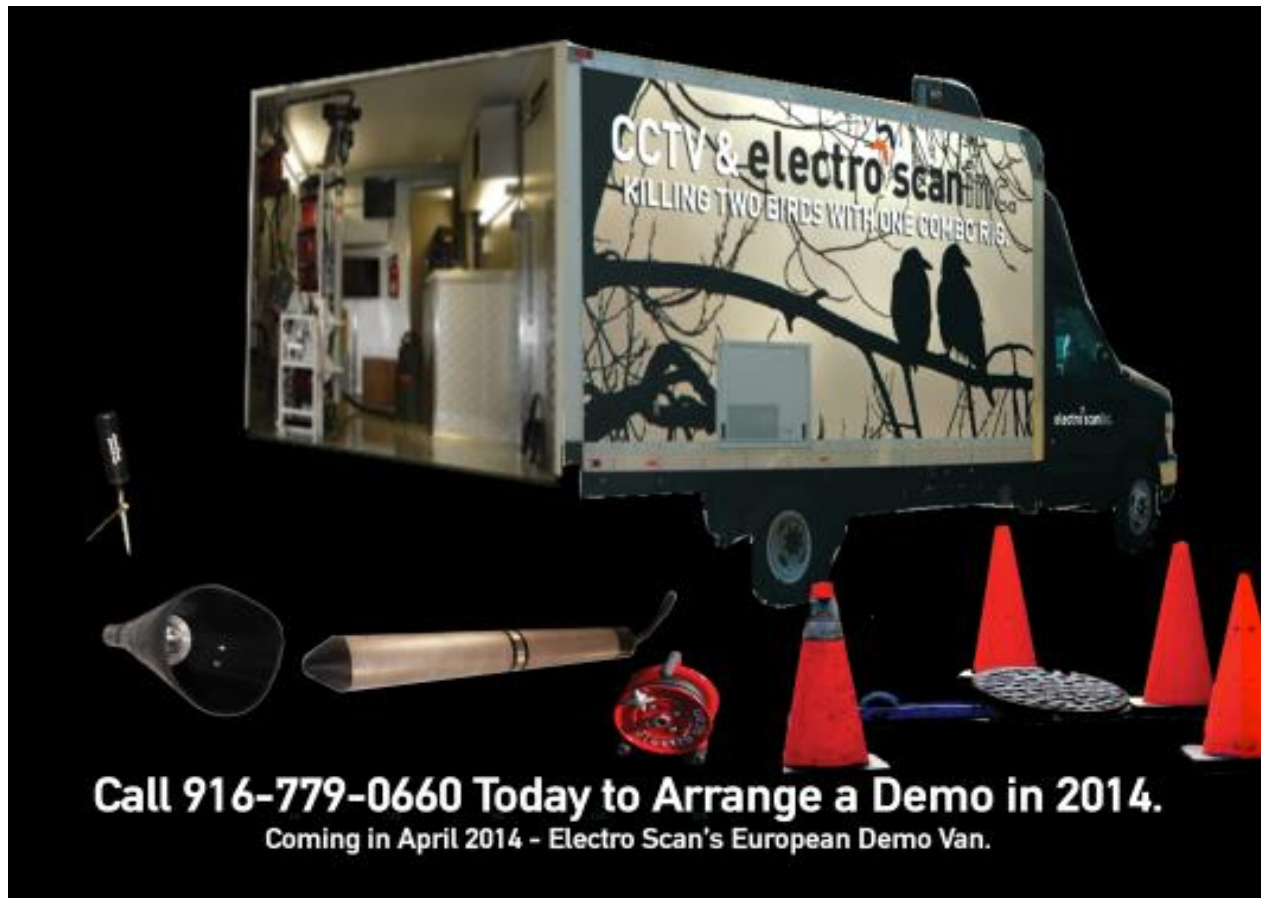
## Electro Scan Truck Model ES-620

(For Detection of “Leaks” in Sewer  
Due to Openings)
